Building to Resist the Effect of Wind, Volume 3:
A Guide for Improved Masonry and Timber
Connections in Buildings

NBS BUILDING SCIENCE SERIES 100-3

VOLUME 3: A Guide for Improved Masonry and Timber Connections in Buildings

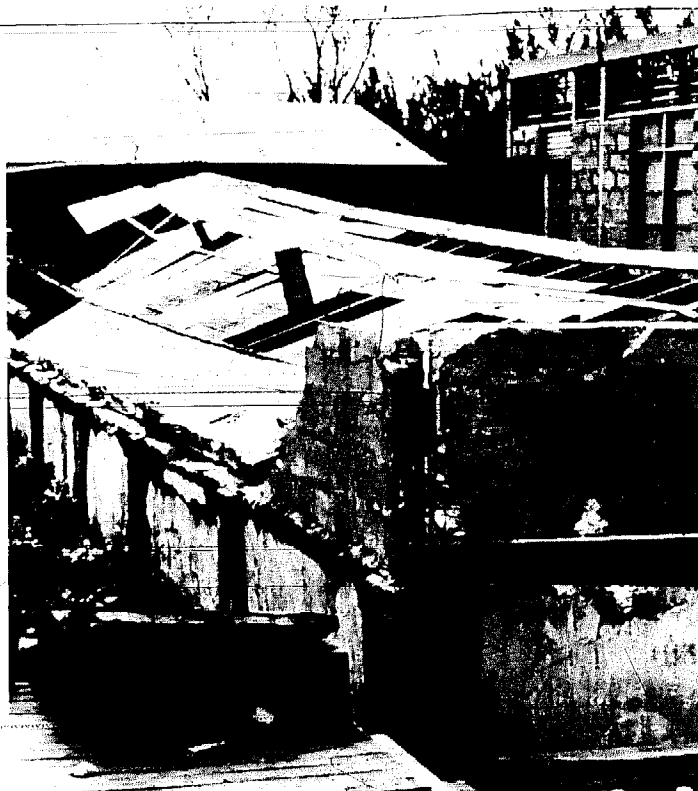
FIGURE 8 COLLAPSE OF ONE-STORY BUILDING CAUSED BY THE NOVEMBER 1974, TYPHOON IN THE PHILIPPINES.

Figure 10 exhibits a typical failure of the fasteners connecting the purlins to the top chords of the trusses. Most of the roofing was "peeled off" in this manner. Portions of the corrugated iron roofing found on the ground contained the purlins with their metal wire attachments still in place (fig. 50). Instability of the trusses, few of which were still standing, was attributed to the loss of purlins and the absence of other longitudinal bracing between the trusses. The collapse of the masonry walls as shown in figure 8 was likewise attributed to the loss of lateral support at the roof level. However, the extent and severity of wall damage is also attributed to the absence of connections between abutting walls and the ineffectiveness of the vertical anchorage at the base. As indicated in figure 9, the only anchorage consisted of steel plates bolted to the wood posts. Close inspection revealed severe corrosion of these plates, especially at the ruptured section through the bolt-holes (fig. 9). The masonry walls in these buildings were nonload-bearing as they were stopped short of the roof to provide openings at the top (fig. 8). Thus the wood posts were the only vertical load-bearing elements and with the loss of the roof many of the corner posts were tipped over (fig. 8).

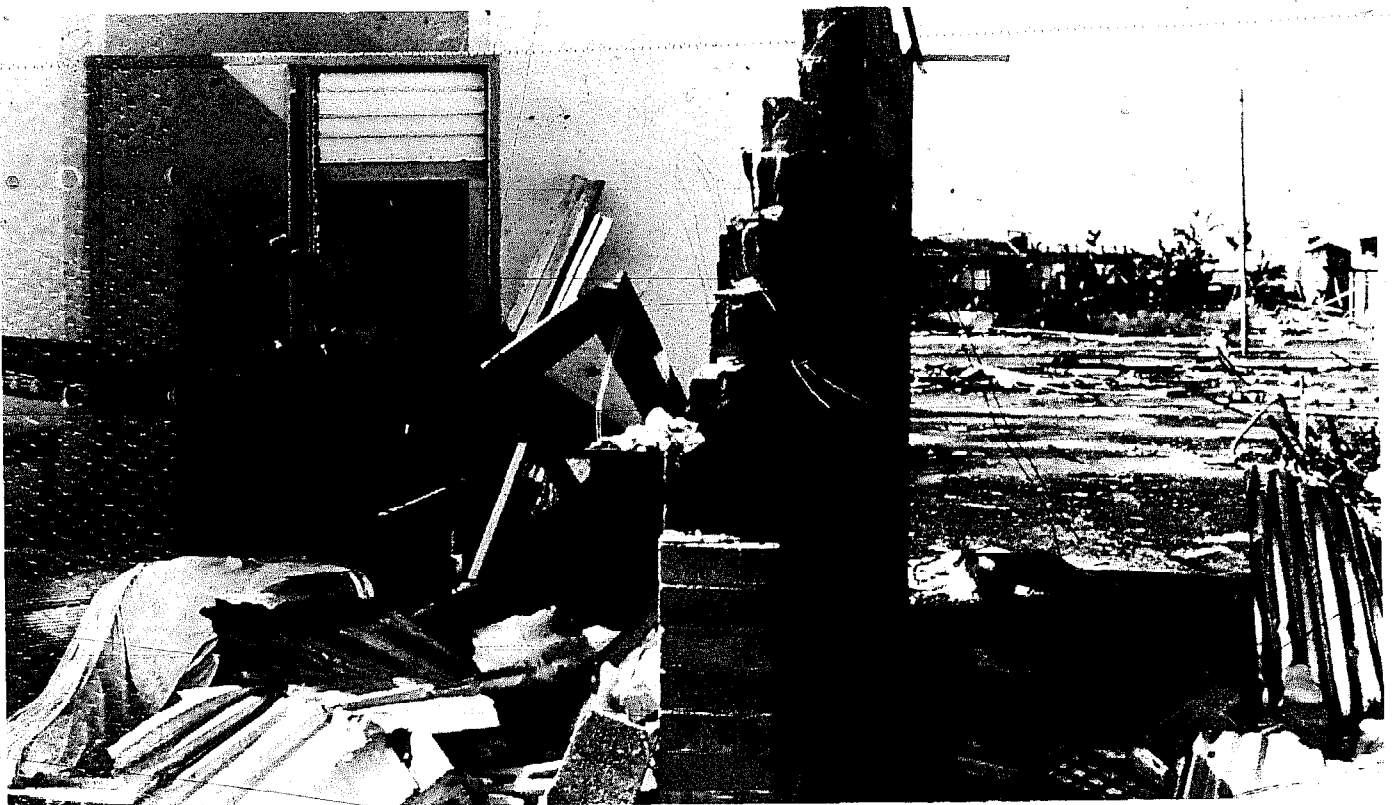
FIGURE 15 BUILDING OF CAVITY WALL CONSTRUCTION IN DARWIN, AUSTRALIA, PARTIALLY DESTROYED BY THE DECEMBER 1974 CYCLONE.

A damage study of the Darwin structures reveals some features worthy of note. In figure 15, it appears that failure occurred at the fourth bed joint from the top, in the inner concrete masonry wythe of the double-wythe cavity wall. Since the inner wythe is the loadbearing component, its failure was probably caused by an outward thrust of the roof under the action of wind. The tilted position of the inner wythe with its top leaning against the brick facing indicates the absence of ties between the wythes near the roof level. The masonry wall in figure 14 consists of two concrete block wythes with a cavity in between. The condition of the reinforcement demonstrates the ineffectiveness of the light-gage ties in assisting the integral functioning of the two wythes in out-of-plane flexure.

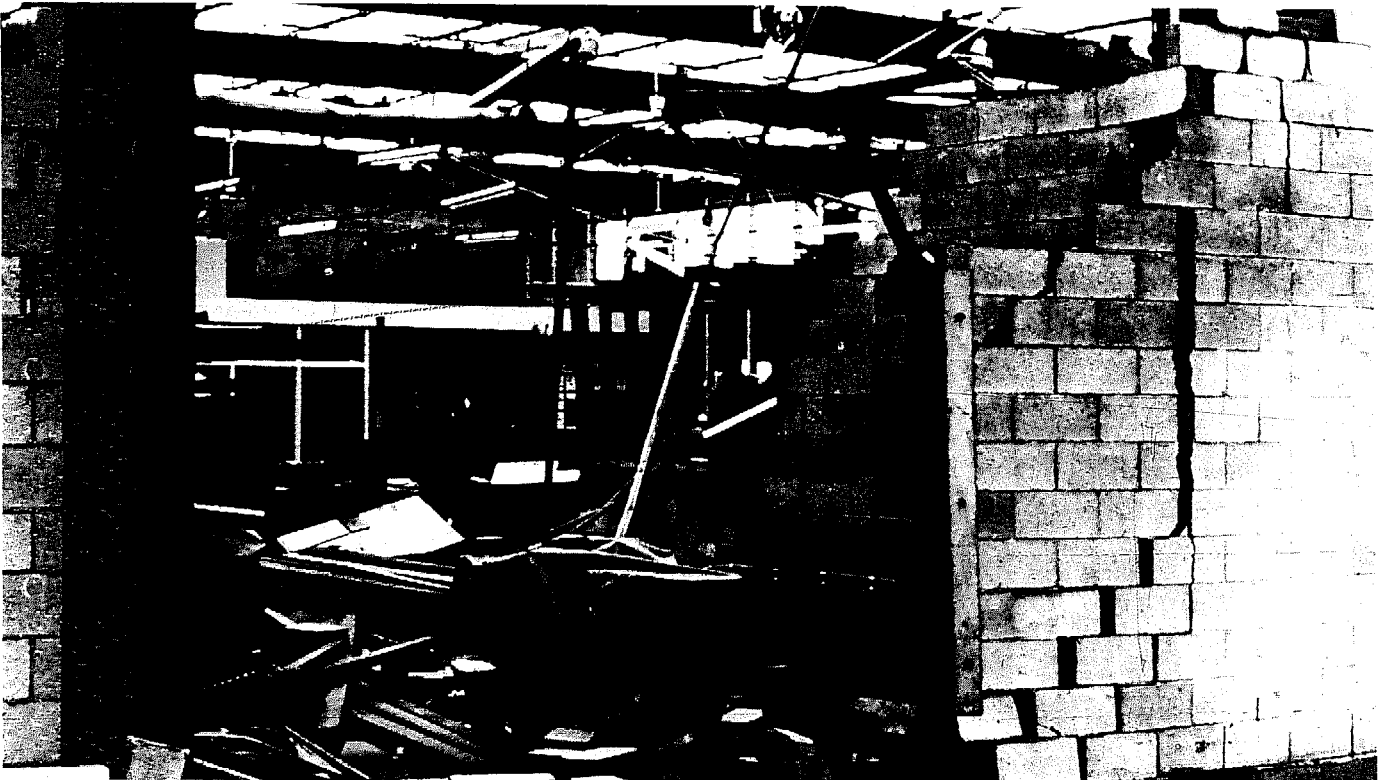
FIGURE 16 BUILDING IN DARWIN, AUSTRALIA SHOWING PARTIAL COLLAPSE OF ROOF AND MASONRY INFILL WALLS CAUSED BY THE DECEMBER 1974 CYCLONE.

Figure 16 shows an infill wall construction with a steel frame and concrete masonry filler walls. There is no visual evidence of any reinforcement having been used in the filler walls. Note the severity of vertical cracking through the wall on the right and also the separation between the steel column and the wall at the left. It is not possible to establish by examination of the figure whether there were any connectors between the steel columns and the filler walls. Figure 17 shows the portion of a concrete masonry wall under the sill of a large window opening that has failed. Note that the top course was connected to the window frame with anchor straps embedded into the grouted cores. It is likely that failure was caused by the movement of the window frame, prying the top course loose from the rest of the wall.

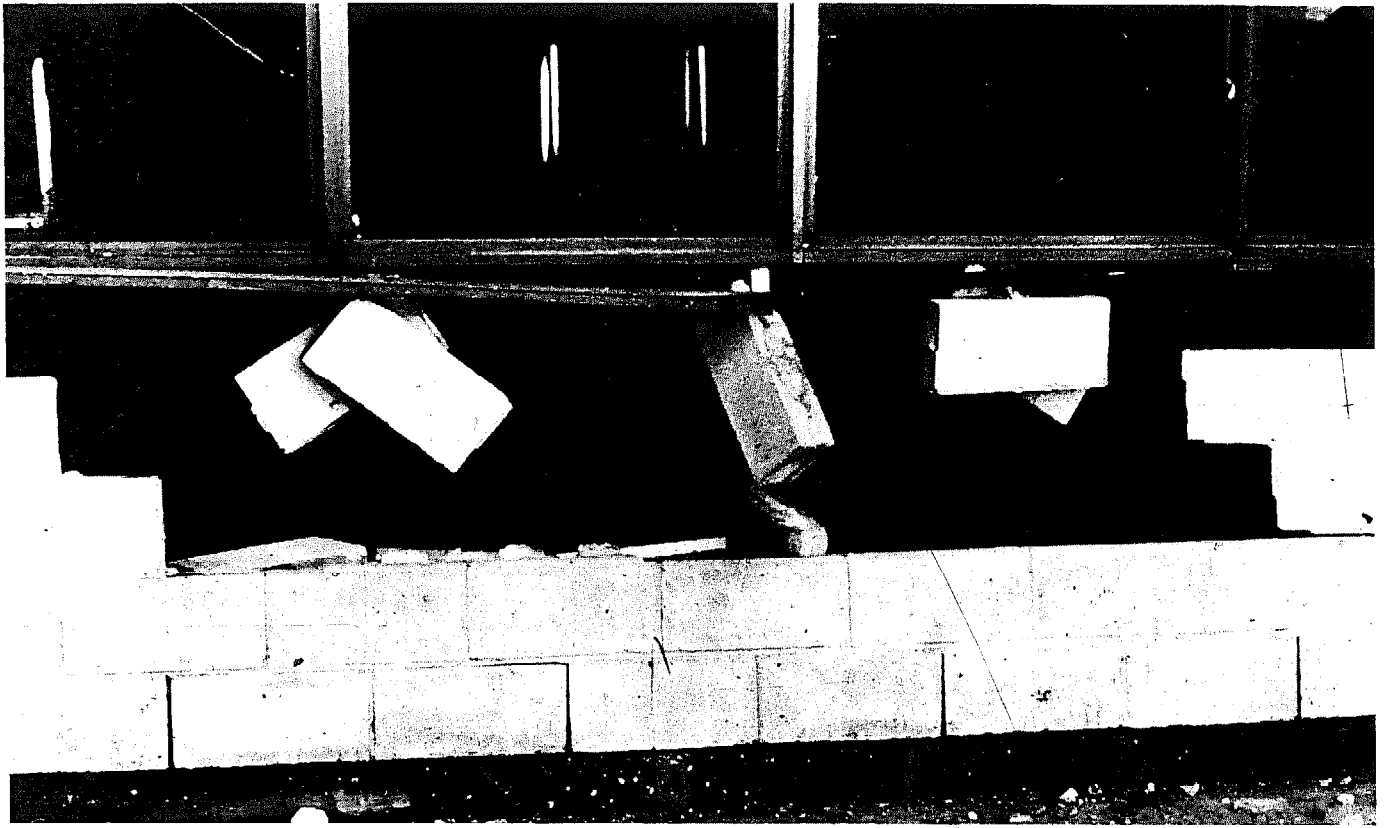
FIGURE 17 FAILURE OF CONCRETE BLOCK MASONRY WALL IN BUILDING
SUBJECTED TO THE DECEMBER 1974 CYCLONE IN DARWIN, AUSTRALIA.

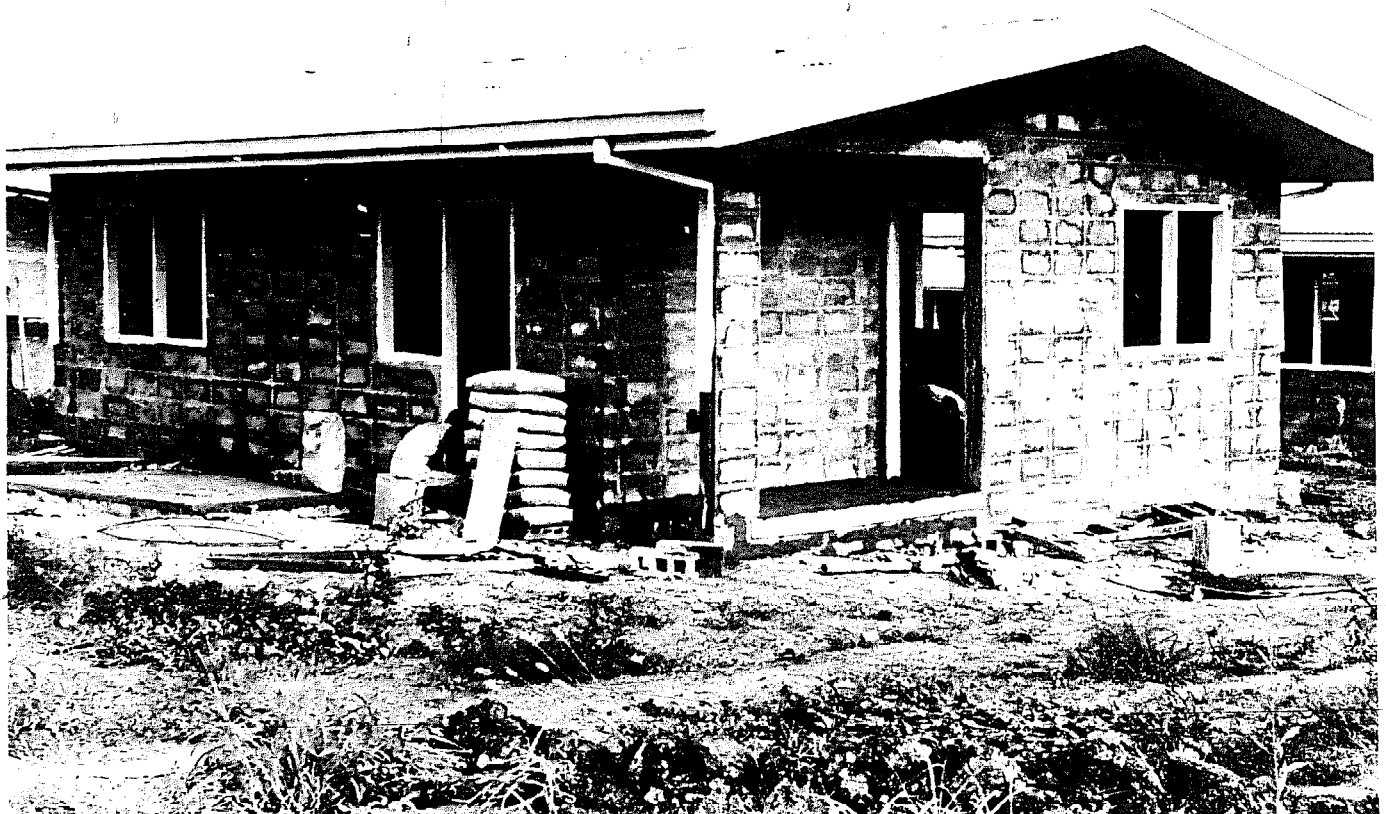
FIGURE 18 SINGLE FAMILY MASONRY HOUSE UNDER CONSTRUCTION IN CENTRAL
LUZON, THE PHILIPPINES.

Figures 18 and 19 show two different stages of construction of a single family house located in Central Luzon, the Philippines. The walls are built with 3-core concrete block units (some of which may be seen lying on the ground in fig. 18). The units are laid in stacked bond to permit placement of reinforcement through the vertically aligned cores. On the basis of figure 19 the quality of masonry construction is deemed inferior by existing masonry standards. Some of the deficiencies noted are: (1) use of defective units, (2) partially filled and non-uniform mortar joints, (3) insufficient horizontal reinforcement for stacked bond construction, and (4) insufficient lintel reinforcement above the openings. It should be pointed out, however, that this system utilizes a peripheral concrete bond beam cast directly above the lintel course (see fig. 18). From the standpoint of overall structural integrity in a severe wind environment, attention is drawn to the practice of using large roof overhangs which are particularly susceptible to wind damage as they are subjected to a positive pressure from below and suction from above [2]. A potentially critical condition also exists in the masonry column supporting a larger overhang at the corner of the landing. Unless substantial top and bottom anchorage and vertical reinforcement is supplied in the column, which is not likely to be the case, given the limited available core space in the single unit section, there is a high probability that the column will fail under the impact of windborne missiles and/or uplift forces exerted by the roof in a severe windstorm.

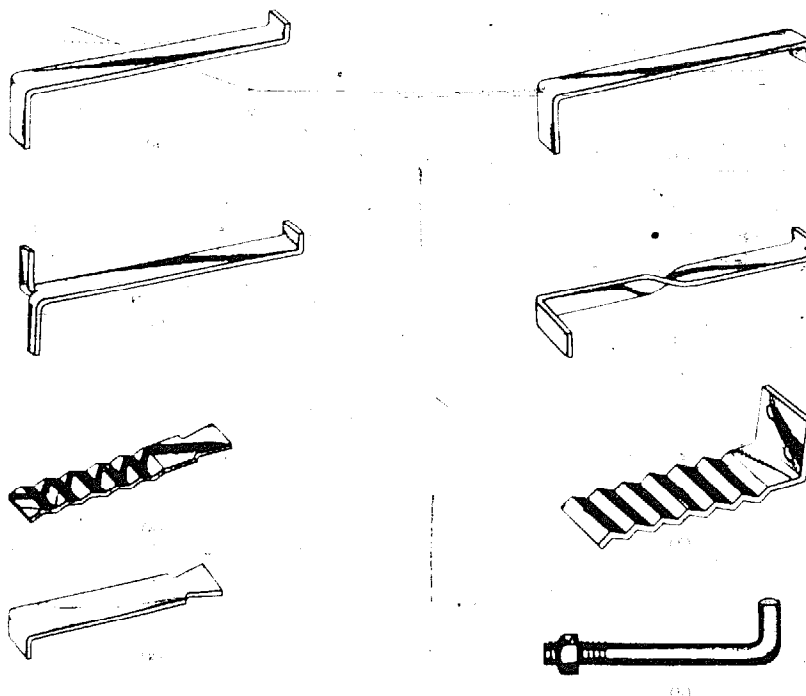
FIGURE 28 VARIOUS METAL ANCHORS: (a), (b) TIEBARS WITH END HOOKS; (c) TIEBAR WITH HOOK AND SPLIT HOOK; (d) TIE BAR WITH 90° TWIST; (e) CORRUGATED DOVETAIL TIE; (f) CORRUGATED TIE; (g) DOVETAIL TIE WITH HOOK; (h) ANCHOR BOLT.

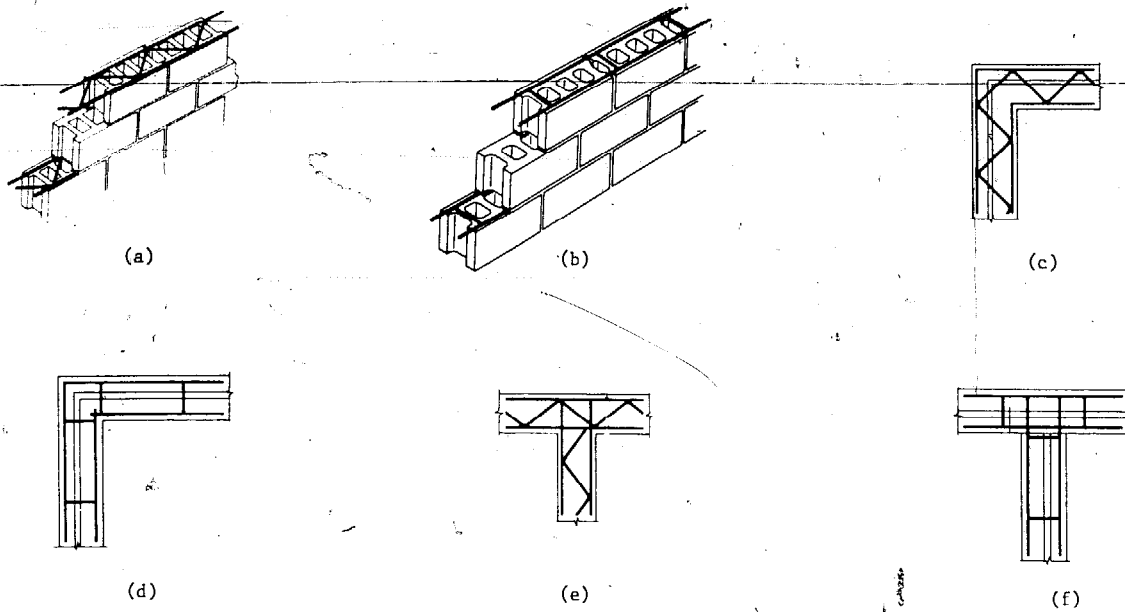
FIGURE 31 JOINT REINFORCEMENT IN MASONRY WALLS: (a) TRUSS; (b) LADDER; (c) AND (d) PREFABRICATED CORNER SECTION; (e) AND (f) PREFABRICATED TEE SECTION.

Figure 31 shows reinforcement designed for placement in the horizontal joints of masonry walls. The two common shapes are the truss and the ladder shown in (a) and (b), respectively. This reinforcement is fabricated from light-gage, cold-drawn steel and consists of two longitudinal rods welded together by cross rods. Joint reinforcement is used as a means to prevent or control cracking in masonry walls and to improve their tensile strength in horizontal flexure.

The use of joint reinforcement is strongly recommended in walls of stacked bond construction which are prone to develop cracking in service along the vertically aligned mortar joints. A good practice is to use them in alternate courses in stacked bond construction and in every third course in running bond construction. Special prefabricated units are also available for continuous reinforcement around corners as in figure 31(c) and (d), and for tying abutting walls and partitions as in figures 31(e) and (f).

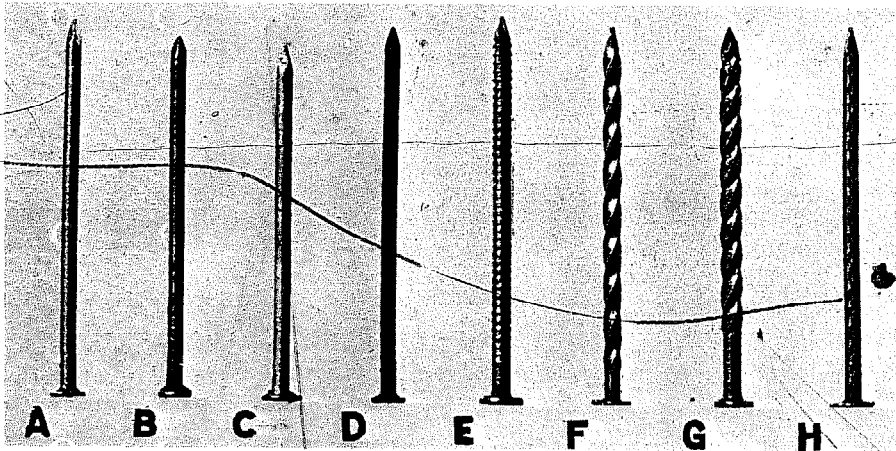
FIGURE 33 VARIOUS TYPES OF NAILS: (a) BRIGHT, SMOOTH WIRE NAIL; (b) CEMENT-COATED; (c) ZINC-COATED; (d) CHEMICALLY ETCHED; (e) ANNULARLY THREADED; (f) HELICALLY THREADED; (g) HELICALLY THREADED AND BARBED; AND (h) BARBED.

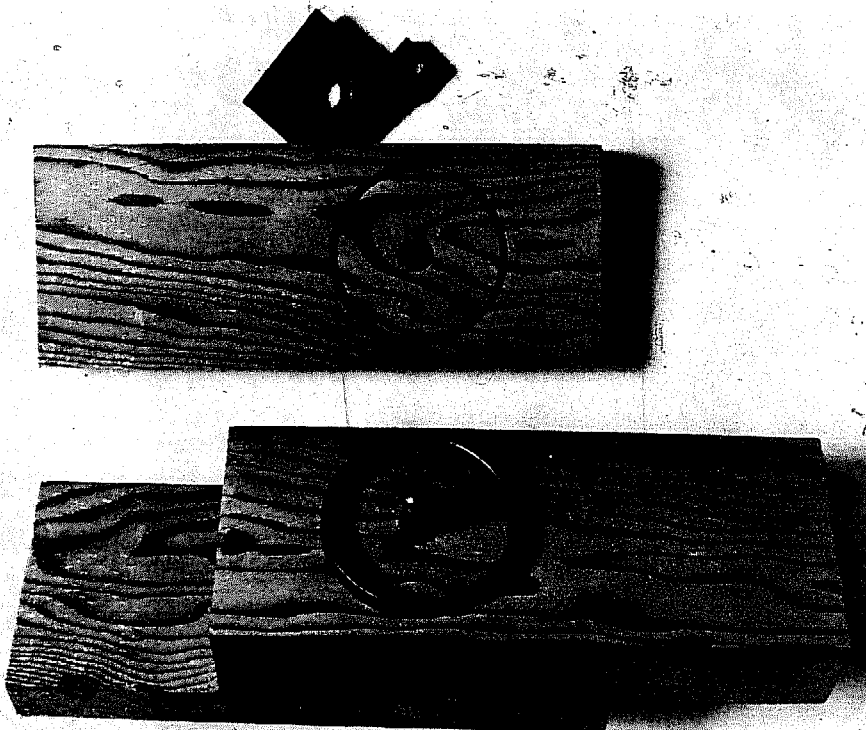
FIGURE 34 JOINT WITH SPLIT-RING CONNECTOR SHOWING CONNECTOR, PRECUT GROOVE, BOLT, WASHER, AND NUT.

Split rings and toothed rings are used for wood-to-wood joints, and shear plates are used for wood-to-steel joints, and sometimes for wood-to-wood joints. Proper joint design procedures and loads can be found in ref. [47].

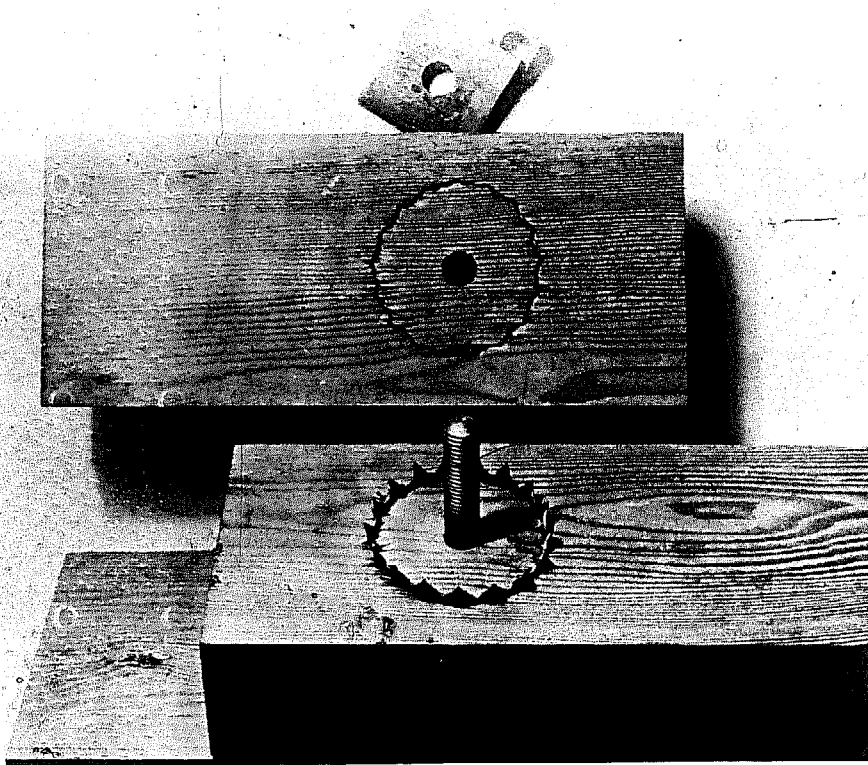
FIGURE 36 JOINTS WITH SHEAR-PLATE
CONNECTORS WITH (a)
WOOD SIDE PLATES; AND
(b) STEEL SIDE PLATES.

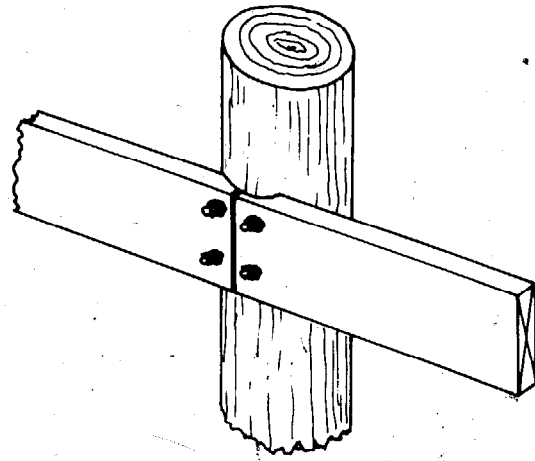
FIGURE 54 TWO FRAMING MEMBERS BUTTED END-TO-END OVER FLAT NOTCH AND BOLTED TO A POLE.

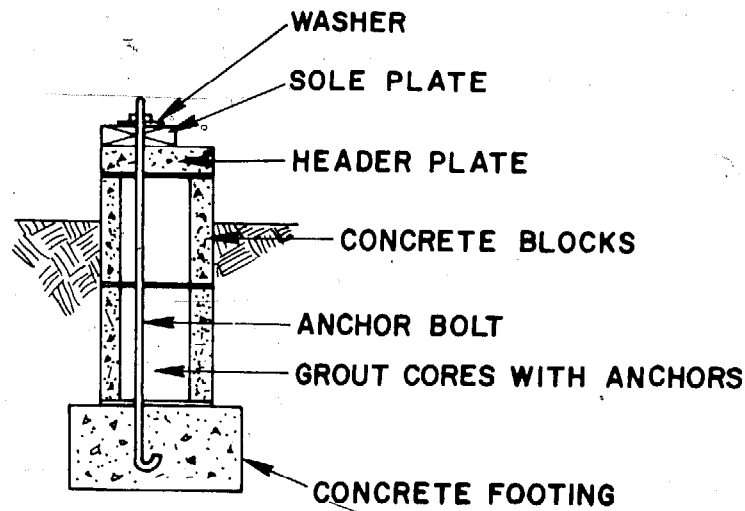
FIGURE 55 ANCHOR BOLT IN CONCRETE A MINIMUM OF 0.2 m (8 in); WASHER TO SPREAD LOAD.

two anchor bolt applications: (a) anchorage of sill to masonry wall and (b) anchorage of stud wall to masonry wall. Also consult figures 55 and 56 which illustrate the use of anchor bolts to connect a stud wall system to cast concrete slab footings and concrete masonry foundation walls.

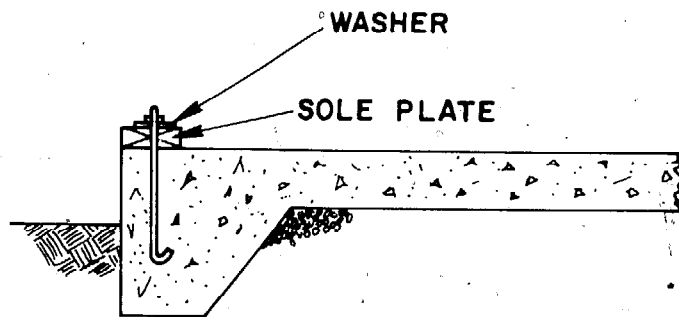
FIGURE 56 ANCHOR BOLT THROUGH CONCRETE BLOCK FOUNDATION INTO FOOTING.

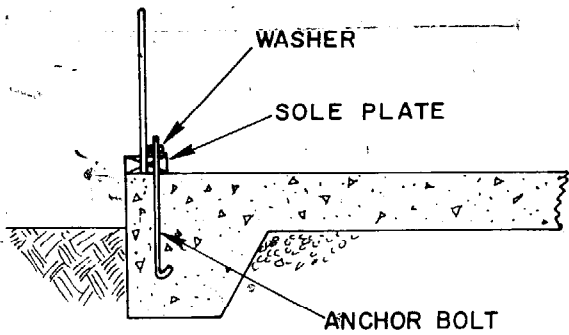
FIGURE 57 ANCHOR BOLT INSTALLED ON PROTECTED SIDE OF WALL.

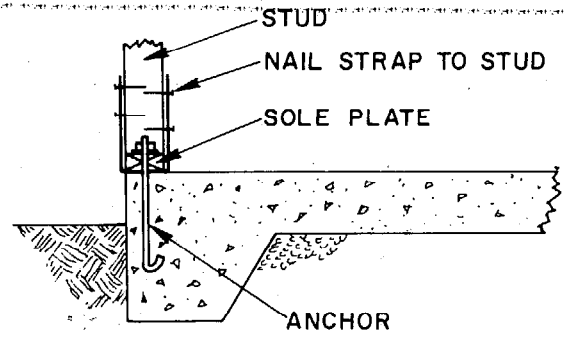
FIGURE 58 SHEET METAL STRAP TYING STUD TO BOTTOM PLATE.

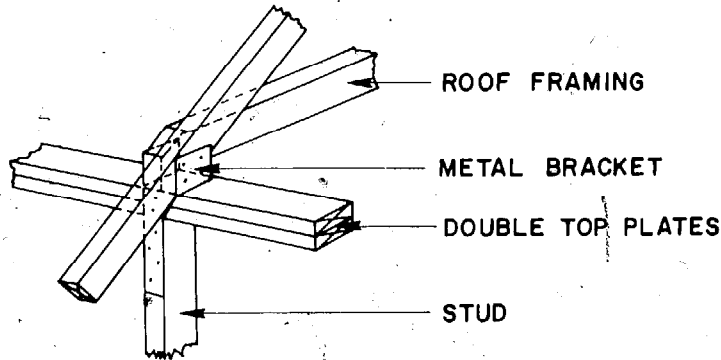
FIGURE 59 SHEET METAL BRACKET FOR TYING ROOF FRAMING TO WALLS.

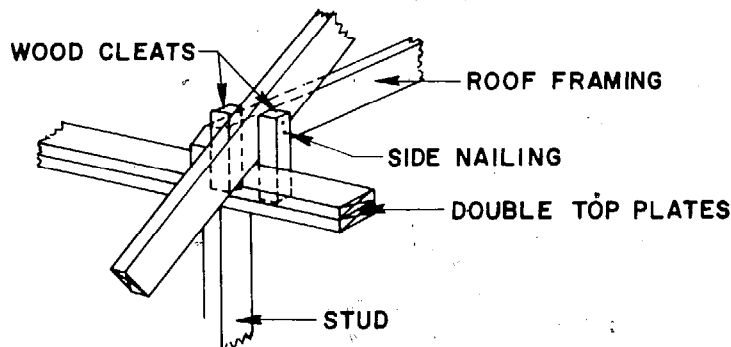
FIGURE 60 WOOD CLEATS NAILED TO EACH SIDE OF ROOF FRAMING AND TO TOP PLATES.

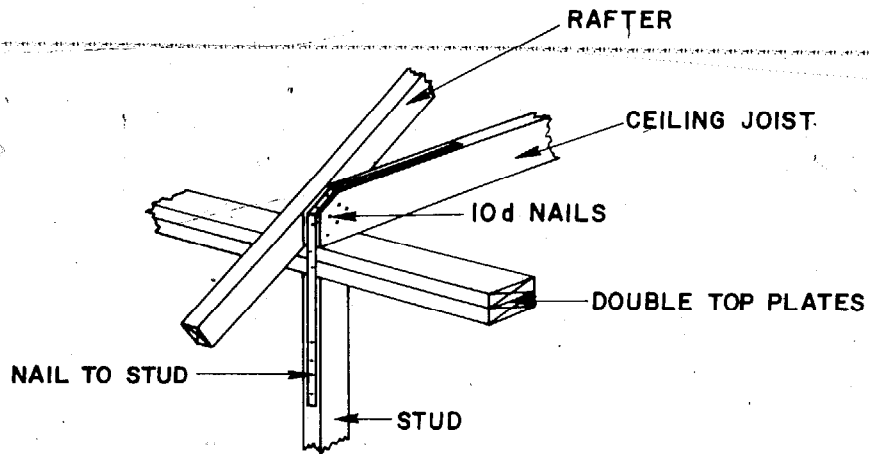
FIGURE 61 SHEET METAL STRAP NAILED TO CEILING JOIST AND STUD TO ANCHOR ROOF FRAMING TO WALL.

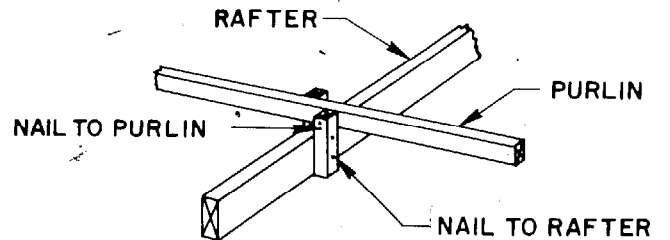
FIGURE 63 PURLINS TIED TO RAFTERS BY WOOD CLEATS.

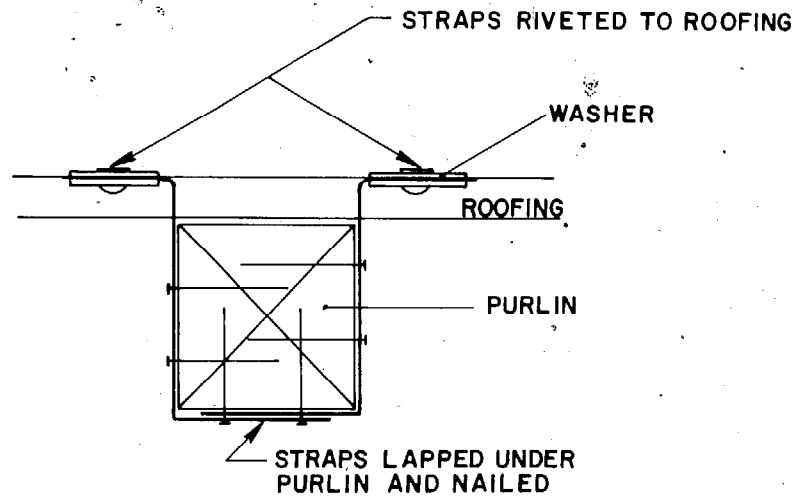
FIGURE 64 TWO METAL STRAPS RIVETED TO CORRUGATED ROOFING, LAPPED UNDER PURLIN AND NAILED TO PURLIN.

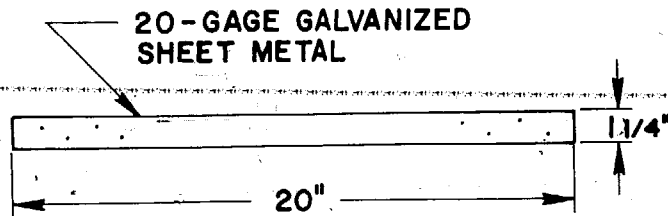
FIGURE 65 MULTI-PURPOSE STRAP; LENGTH AND WIDTH CAN BE VARIED FOR SPECIFIC APPLICATIONS.

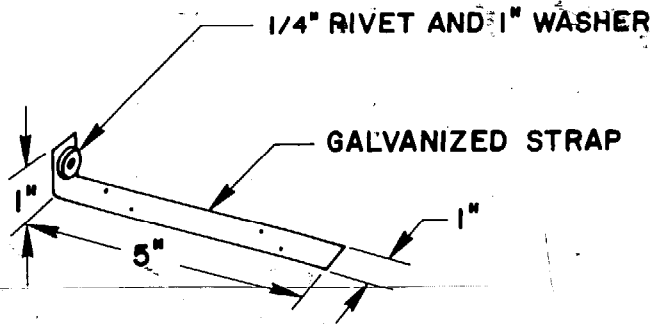
FIGURE 66 GALVANIZED SHEET METAL STRAP WITH RIVET AND WASHER FOR TYING DOWN CORRUGATED ROOFING.

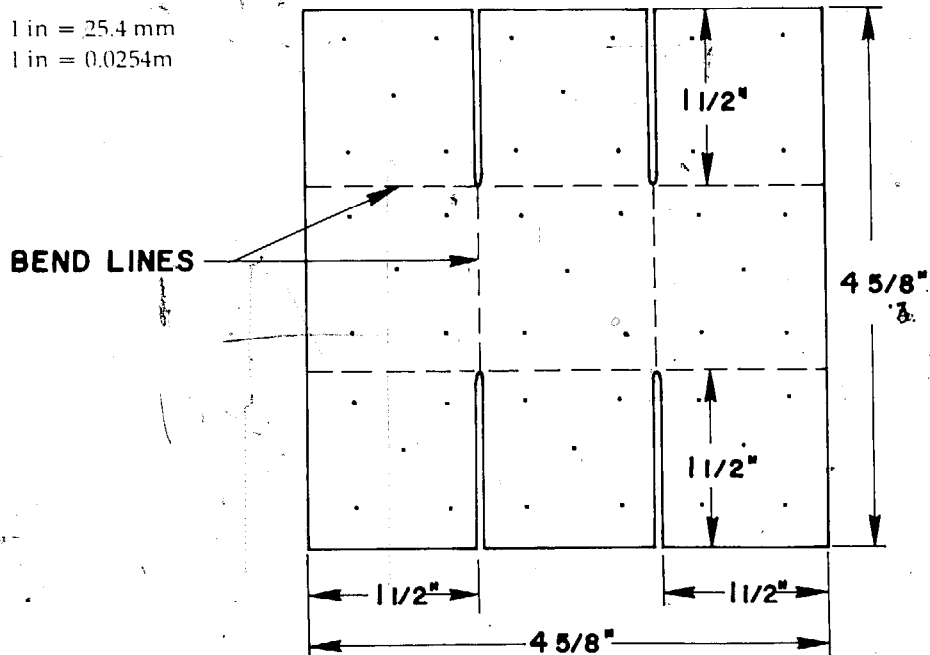
FIGURE 67 MULTI-PURPOSE BRACKET FABRICATED FROM 20-GAGE GALVANIZED STEEL; BEND EITHER DIRECTION AT BEND LINES TO FORM DESIRED BRACKET.

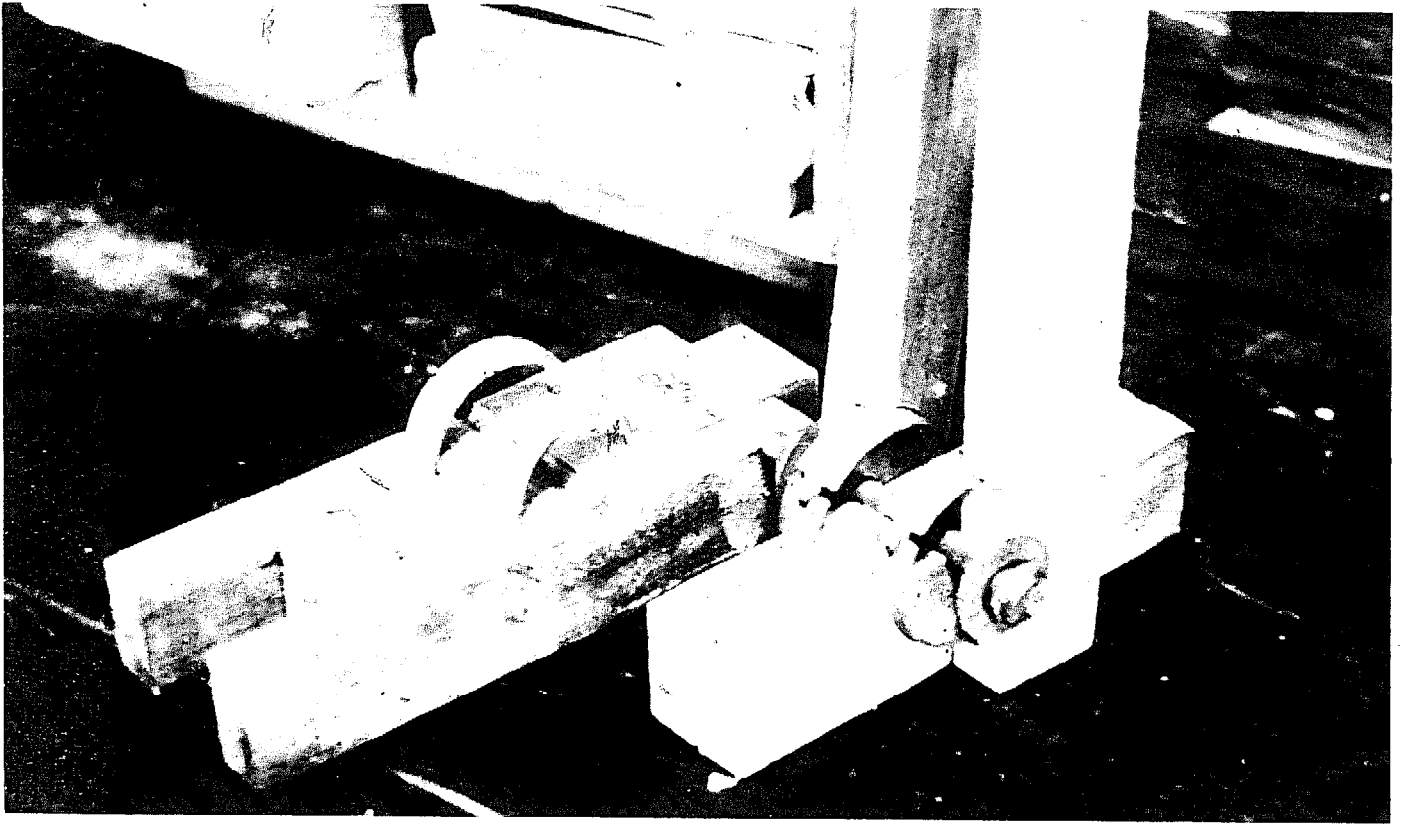
FIGURE 68 SPLIT-RING CONNECTOR FOR INDIGENOUS FABRICATION (LEFT), AND
COMMERCIALY PRODUCED SPLIT-RING CONNECTOR (RIGHT).
